LOVELL LAKE DAM
NH 00223

PHASE I INSPECTION REPORT
NATIONAL DAM INSPECTION PROGRAM

AUGUST 1978

Identification No.: NH00223
Name of Dam: Lovell Lake Dam
Town: Wakefield
County and State: Carroll County, New Hampshire
Stream: Branch River
Date of Inspection: 19 June 1978

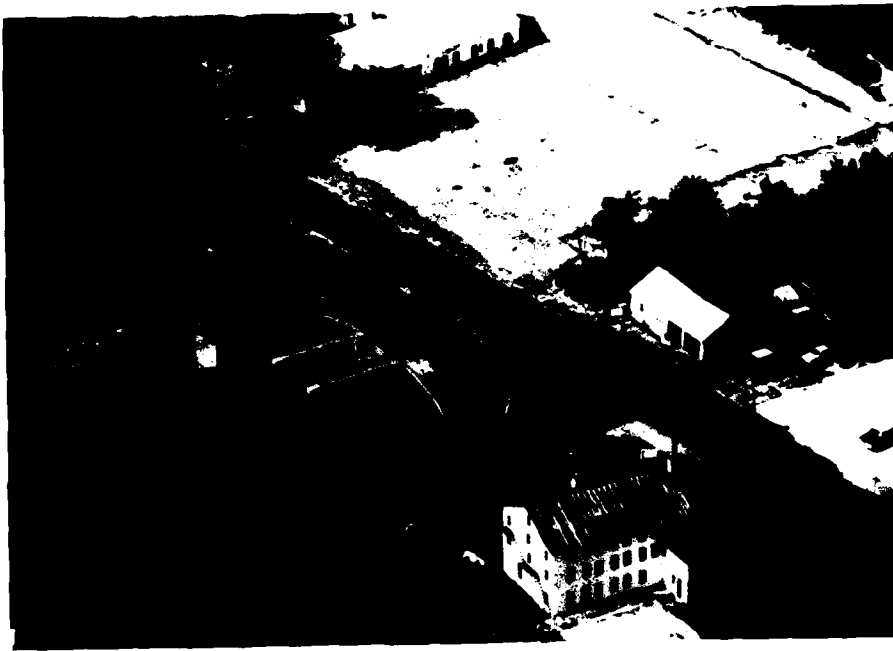
Figure 1 - Overview of Lovell Lake Dam.

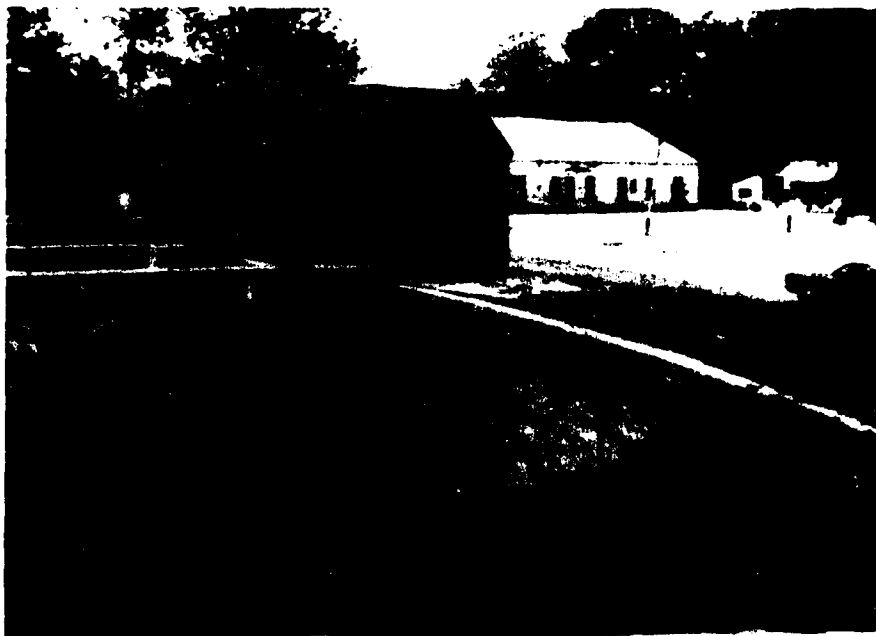
Figure 3 - Looking southwest at the upstream face of the dam.

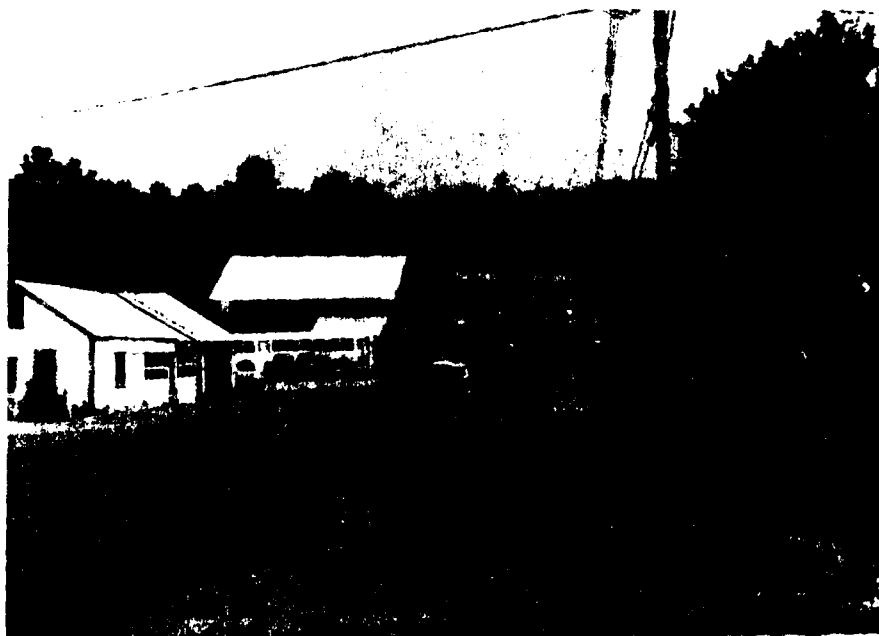
There are two seepages downstream of the dam. One of the seepages discharges at the east edge of the pavement on State Route 109 downstream from the downstream dry masonry wall. (See Appendix C - Figure 7.) The pavement is broken and the shoulder is soft at the location of this seepage. The water being discharged was clear at the time of the inspection. The second seepage is taking place about 13 feet from the downstream toe near the bathing beach at the south abutment. (See Appendix C - Figure 8.) The elevation at which the seepage was discharging was only 1.4 feet below lake level at the time of the inspection. The water being discharged was clear.

Figure 7 - Looking north along Route 100. The downstream face of the dam is visible at the extreme right edge of the photo. Note the deep gap in the vegetation at the nearest telephone pole.

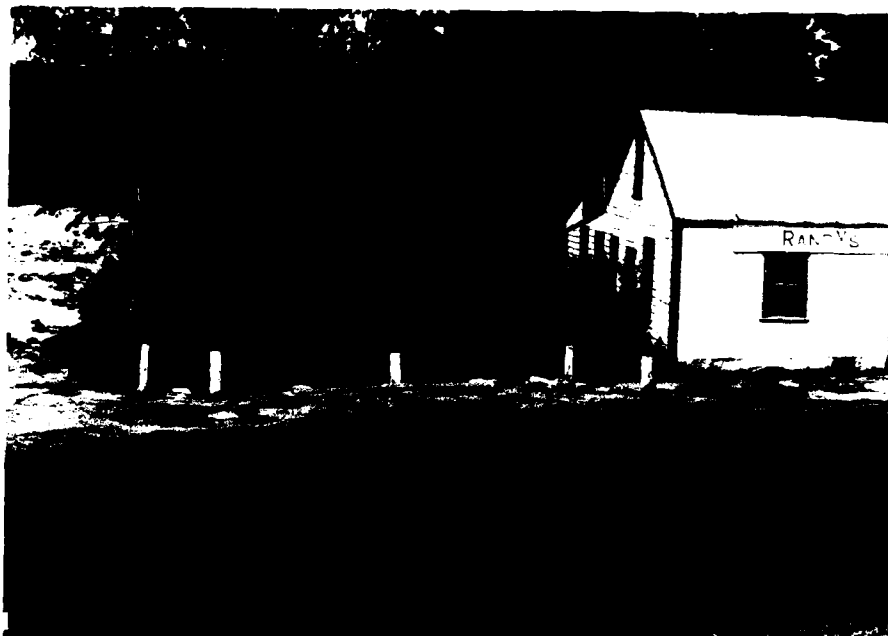
Figure 14 - Looking from the storage shed at the channel downstream of Route 109.
